# SR 2 Landslide - Project Update

March 13, 2018

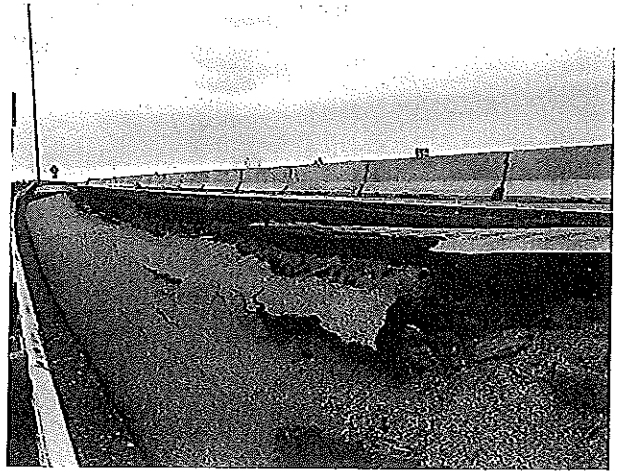
On Wednesday, November 29, ODOT closed the ramp from westbound SR 2 to northbound SR 269 (exit 125) because the difference in pavement heights was expanding. Shortly thereafter, the pavement slid, as seen in the picture.

- Mid November: Crews noticed the pavement was cracked in the shoulder of westbound SR 2 at SR 269 (exit 125), so they monitored it. Soon, there was an inch difference in pavement heights, so ODOT engineers were deployed to inspect it, and the shoulder was closed.

- On Wednesday, November 29, ODOT closed the ramp from westbound SR 2 to northbound SR 269 (exit 125), because the difference in pavement heights was expanding. Shortly thereafter, the pavement slid down. Because the area was already closed, nobody was injured in the slide.
